Thomas James Store
Preservation and Interpretation

Preservation 2010 Report

Thomas James Store Structural Stabilization, May-August 2010

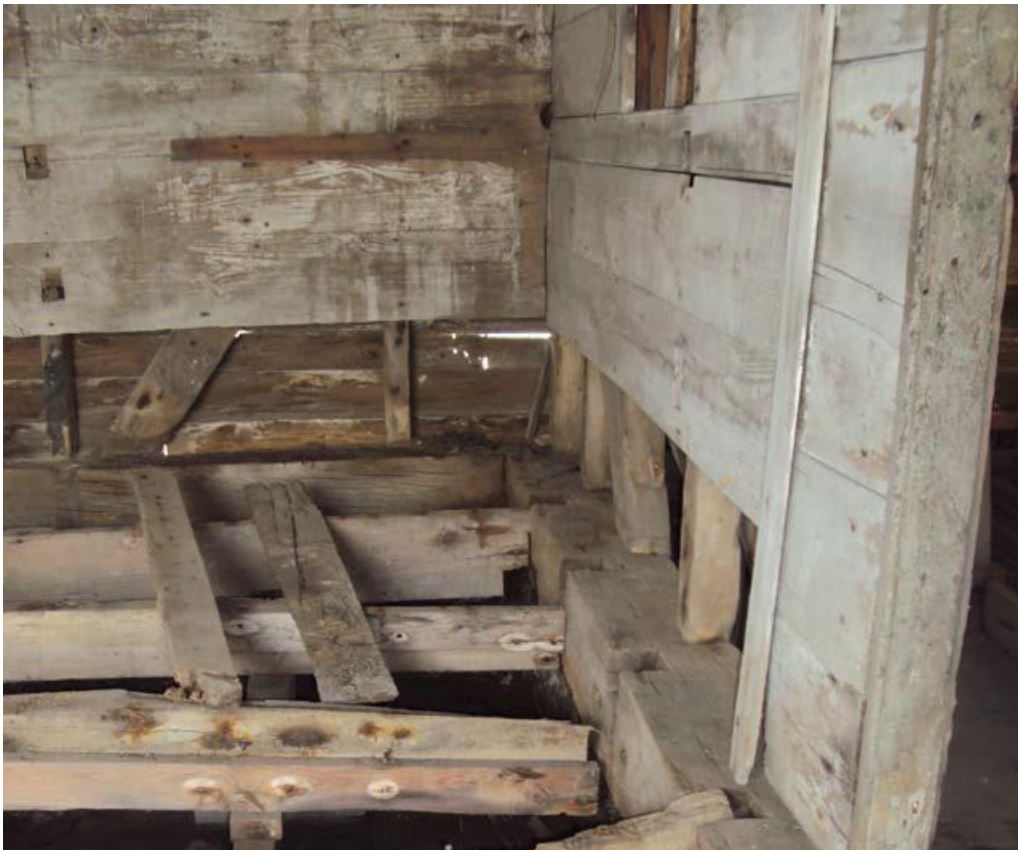
Work on the original building focused on the east and north walls. On the east wall, floor joists that had separated from the sill (fig. 1) were rejoined, using least invasive methods and treated lumber material (fig. 2).

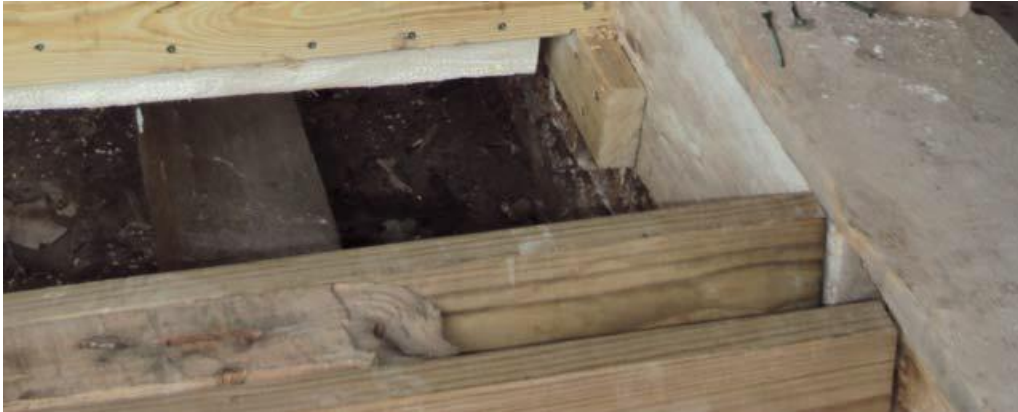
North wall foundations had subsided and were disintegrating due to lengthy moisture problems (fig.3). The central brick pier was removed and cement footings poured (fig. 4).

ment timber. Both the original sill and the insert are now loose. The sill has also suffered from damp rot, which extends to the corners of the north wall. In addition, some of the vertical studs on the north wall have separated from the patched sill, resulting in an unstable wall. Some of the floor joists have separated from the east sill, particularly in the northeast corner of the building. Finally, the foundation has deteriorated, particularly on the north side of the building. At least one of the piers has settled, and many of the bricks and concrete blocks are loose and can be manipulated by hand, indicating severe mortar deterioration.

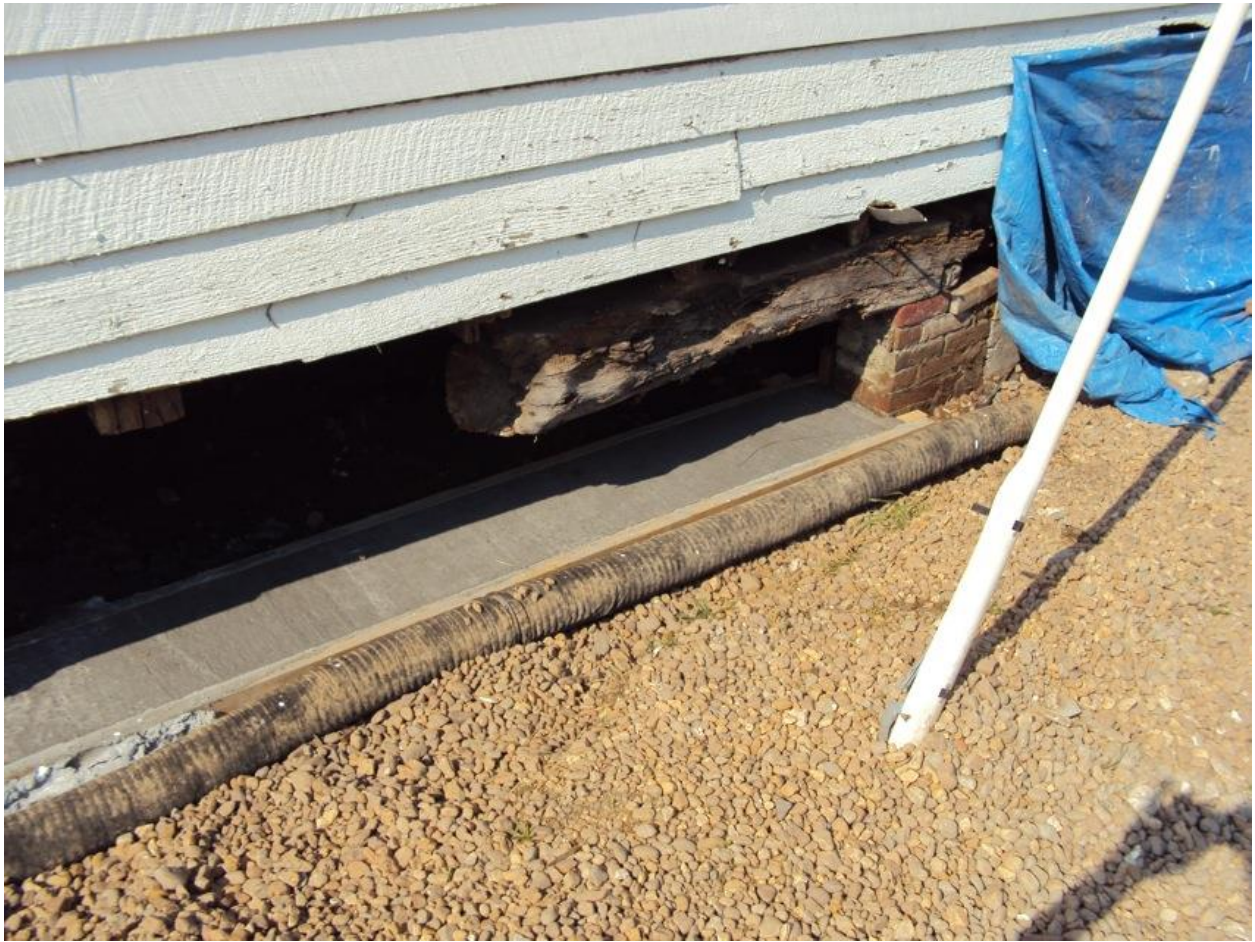
Since the original sill had been cut to fit either side of the original brick chimney, and lacked a central support, a brick wall (consisting of old, local brick, identical in size and color to bricks in the northwest-corner pier, with period-type mortar) was built between the two corner piers (fig. 5). Remnants of the original sill were laid on the brick wall – with a copper sheet moisture barrier – and a treated lumber section shaped at each end and placed between them (fig. 6). Wall joists were strengthened with treated lumber extensions, the whole secured by a new 2x8 treated board placed on its side on the wall (fig. 7).

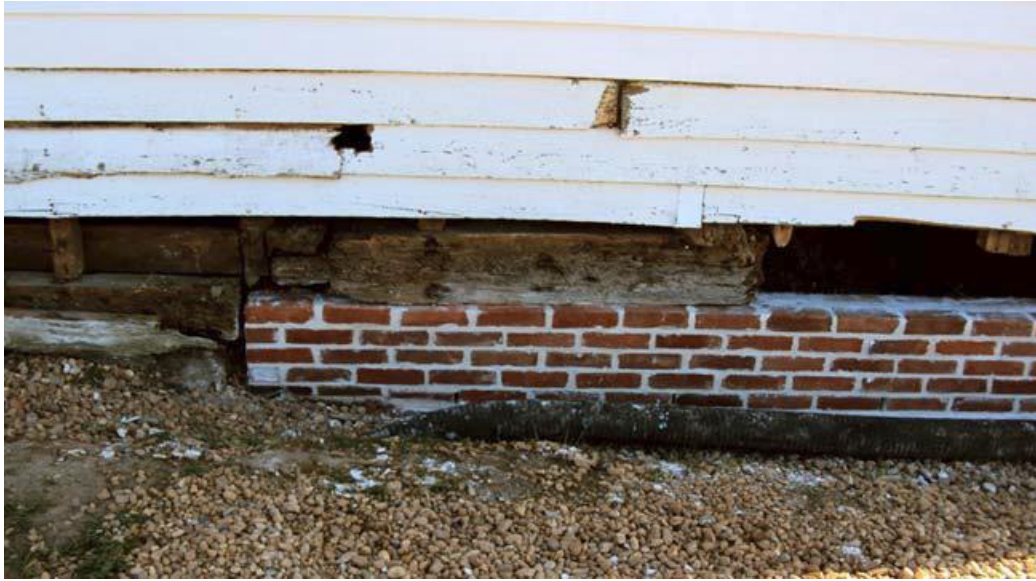
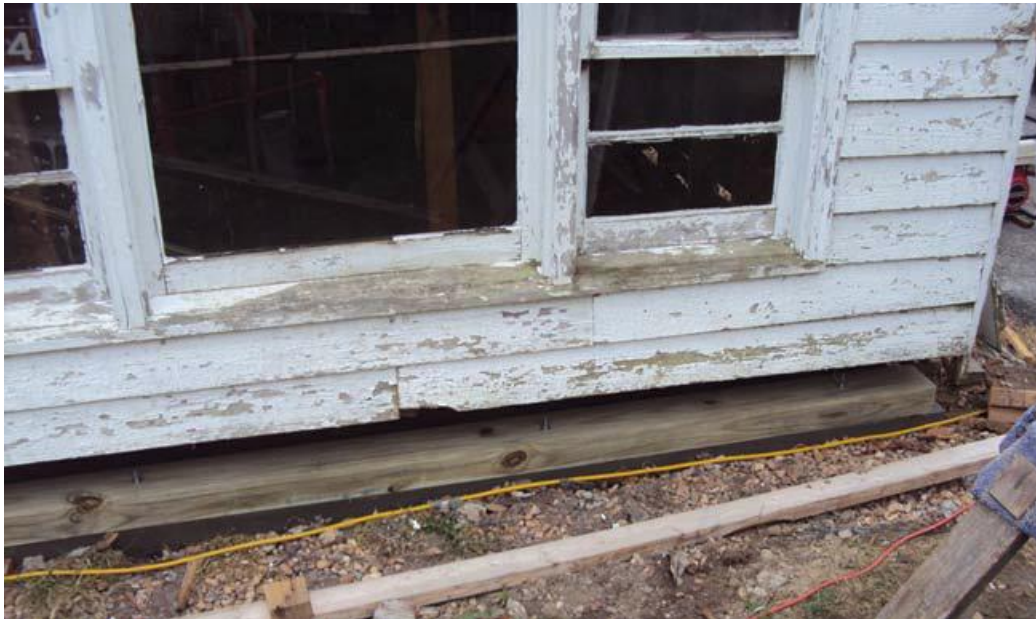
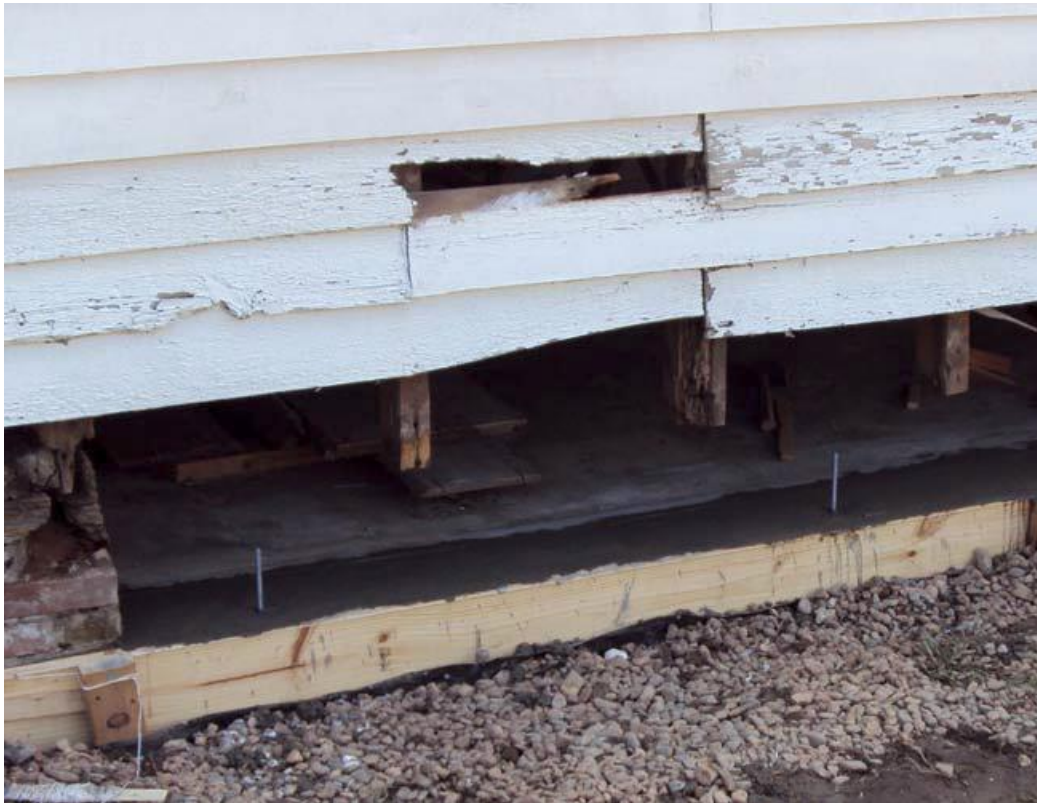
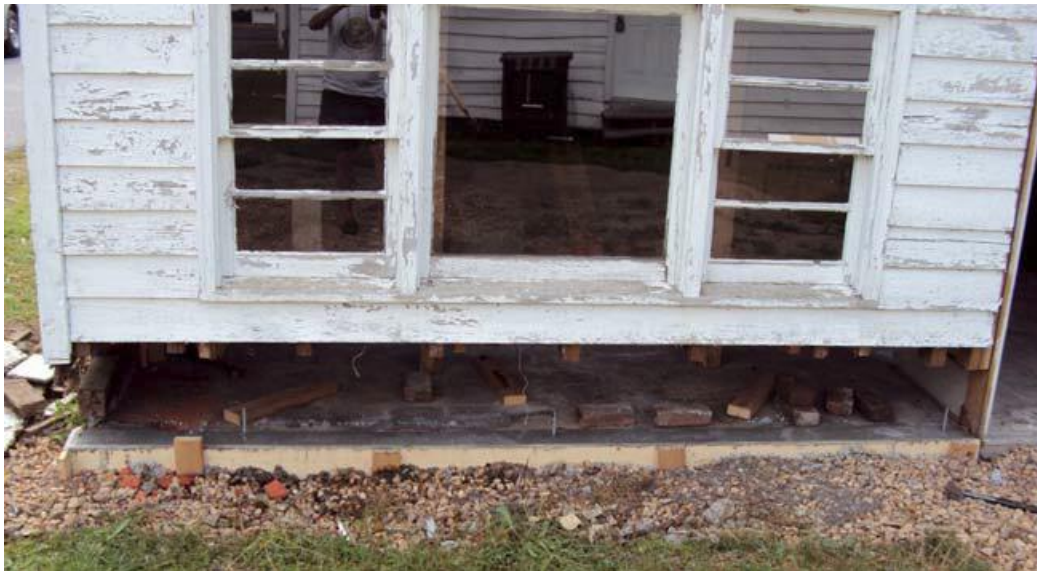
Long-term plans call for future interpretive/public use of the east and west “wings,” so the “**envelope building**” had also to be stabilized. All sills were extensively worm-eaten or rotted (having been laid on the ground, the cement slabs poured inside them), and had to be replaced (figs. 8; 9; 10; 11).

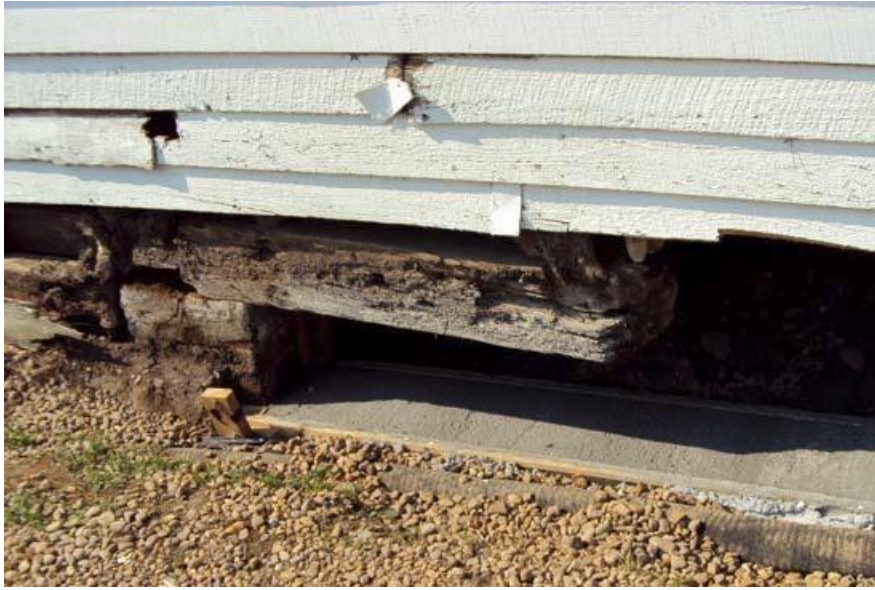
As much of the old (but not original) siding as it was possible to keep was retained, though virtually all of the north wall siding was rotten, much of it crumbling in the hands (fig. 12).

The exterior weatherboard siding on the Thomas James Store is deteriorating in places, most noticeably on the north wall of the building. Some of the wood has been softened by damp rot, causing sagging, cracking, and general weakness. The weatherboards must be repaired or pieced together where possible, with some lengths needing full replacement. Henry Schlenk's cost estimate for repairing and replacing the siding on the north wall alone is \$1600 plus the cost of any replacement lumber. Once the weatherboard siding has been repaired, it is recommended that the building's exterior paint be touched up as necessary rather than being stripped and repainted.

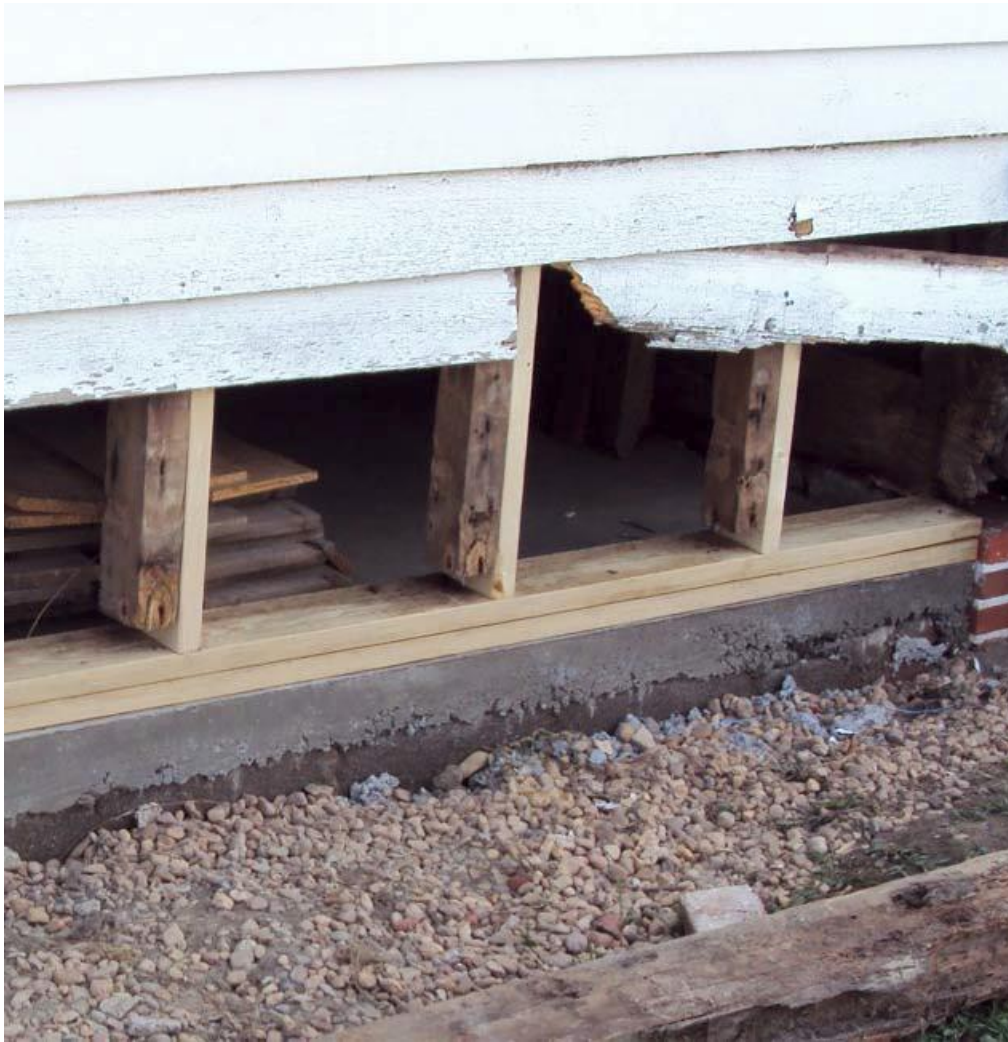
The 1950s west wall treatment (much of it rotten) was replaced by boards and a period-style board door (fig. 13). The west wing had been widened for this addition. This was strengthened (fig. 14).

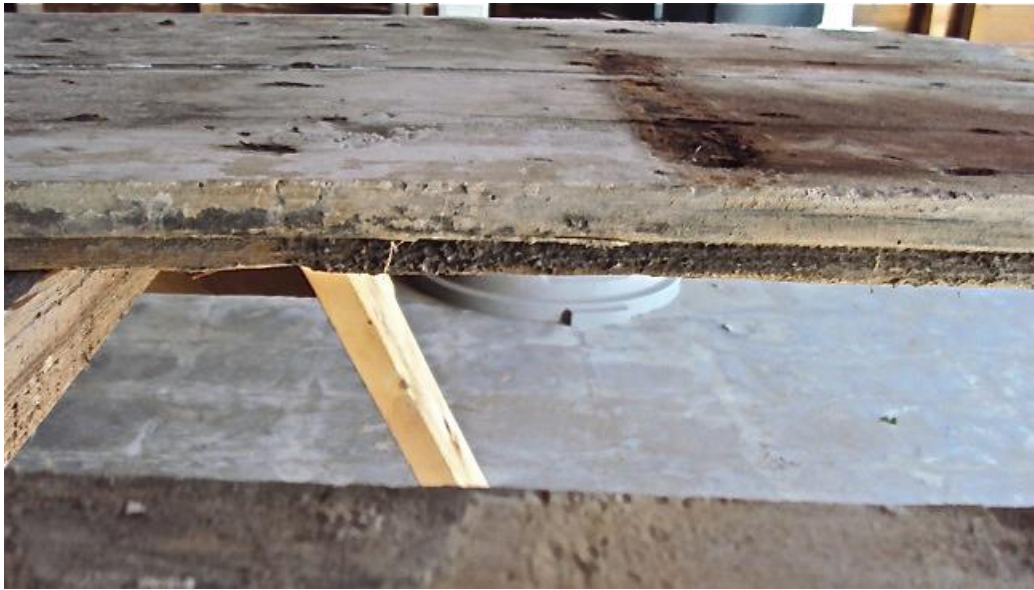
Salt efflorescence on the ceiling (fig. 19) was lightly brushed off, and the dirt on the attic floor, mixed with grease from curing hams, which had been hung from the collar ties (fig. 20) was vacuumed up.

The ceiling boards of the retail room were at one time soaked in brine solution, as the attic of the store appears to have been used to hang cured meat. This has created a salt outgrowth on both the top surface of the boards (the floor of the attic, where it is particularly thick), and the bottom surface (the ceiling above the ground floor, particularly on the south end of the building). The salt could expedite deterioration of the wood, and should be carefully removed when the interior of the building is cleaned. To do so, both the top and bottom of the ceiling boards will need to be brushed and vacuumed. Henry Schlenk estimated that this process would cost approximately \$600.

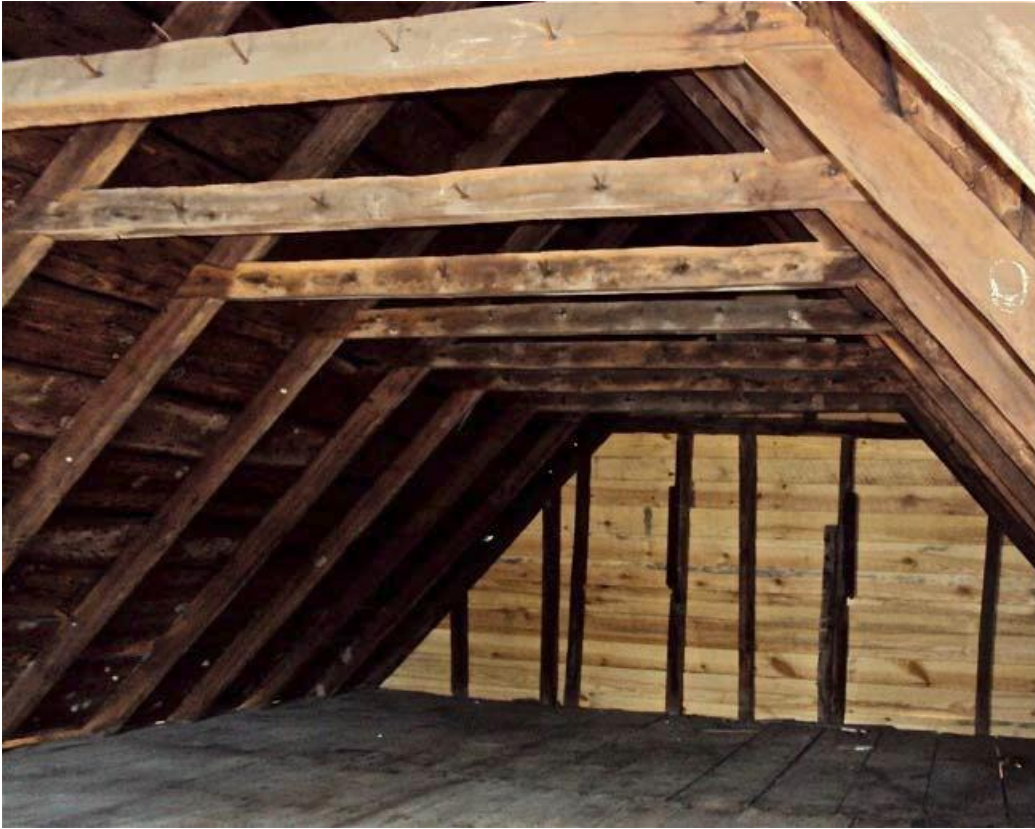
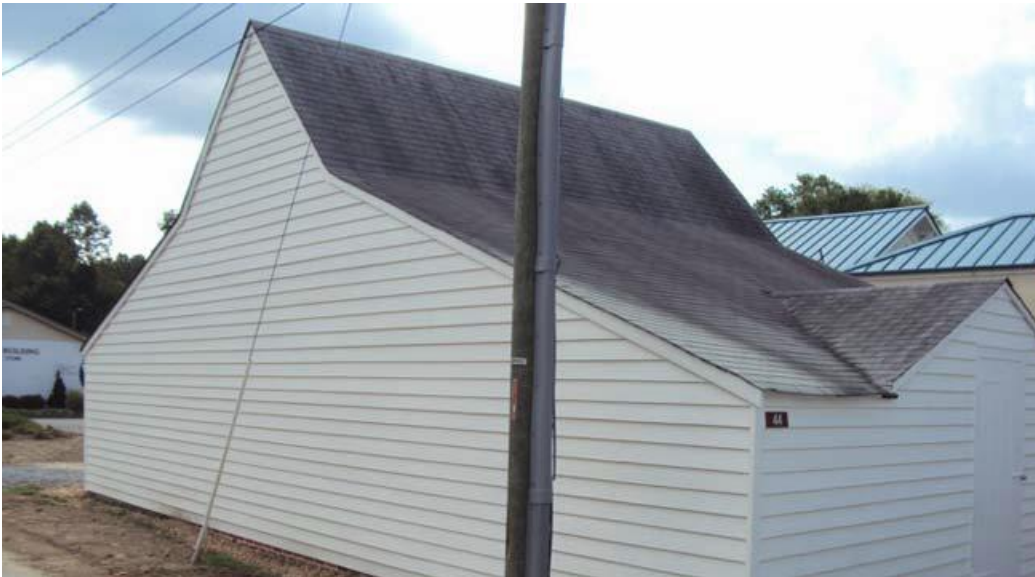
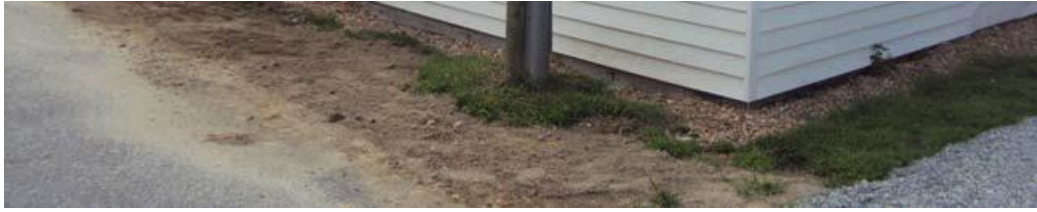
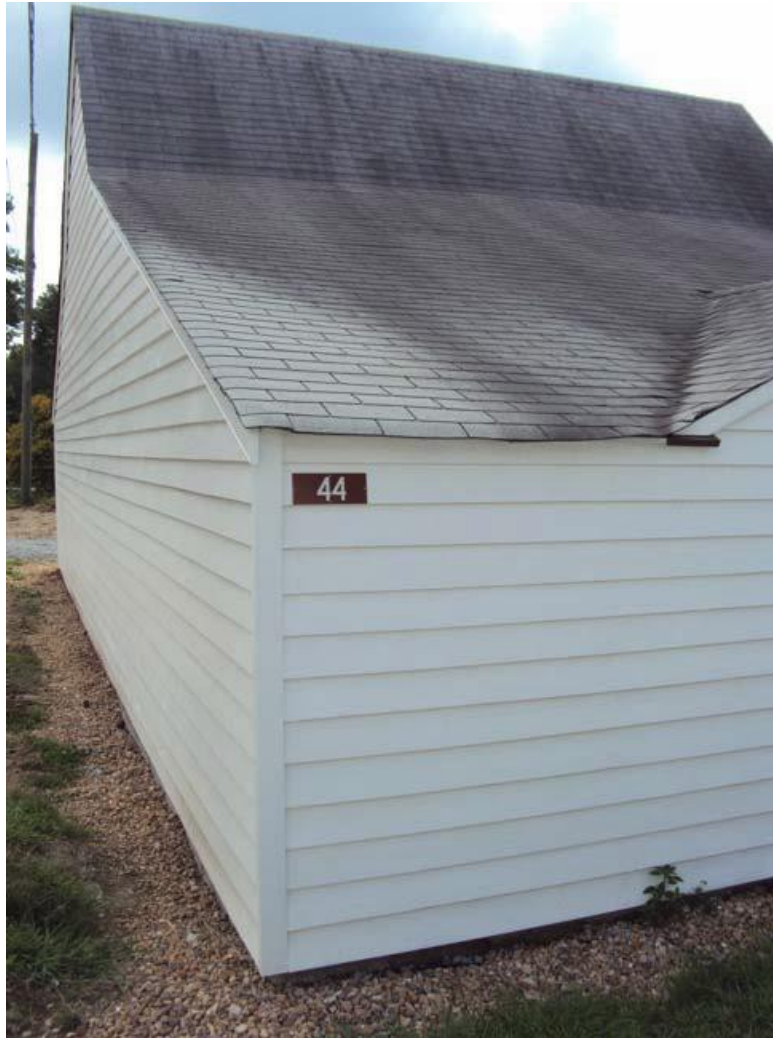
All new exterior siding was primed and the whole building painted (figs. 21; 22; 23; 24).

In the fall of 2009, a drain was installed around the entire building (most visible in figs. 23 and 24). The building is now registered as an archaeological site with the Commonwealth of Virginia's Department of Historic Resources.
