Architectural Description – Exterior

Thomas James Store
Architectural Information

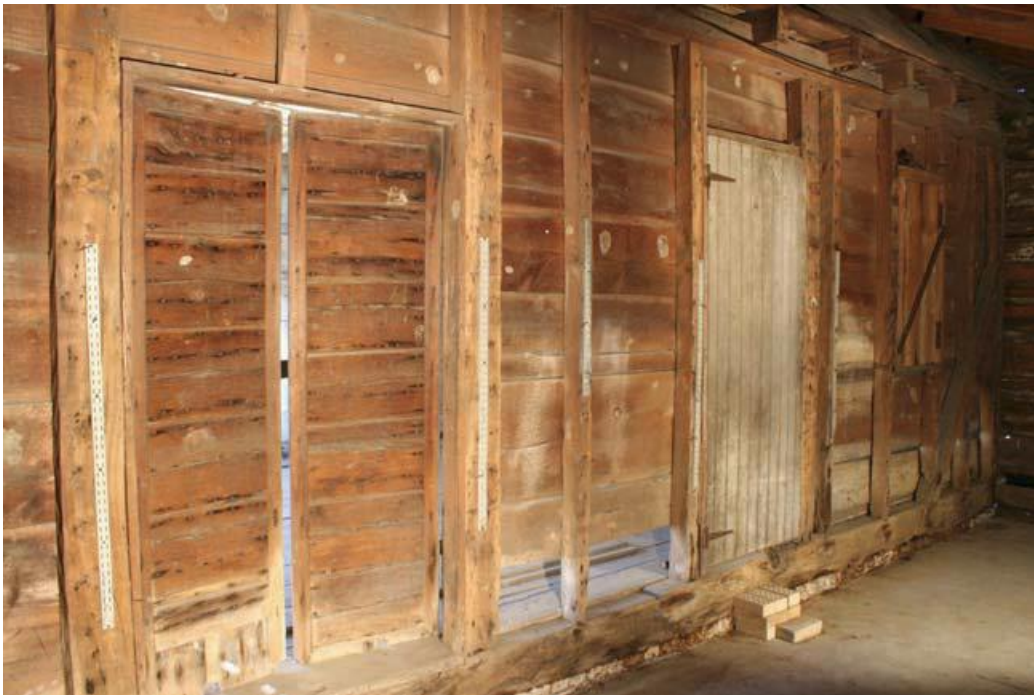
Exterior of original front (now east) wall of old store - photo by Jorin Hood

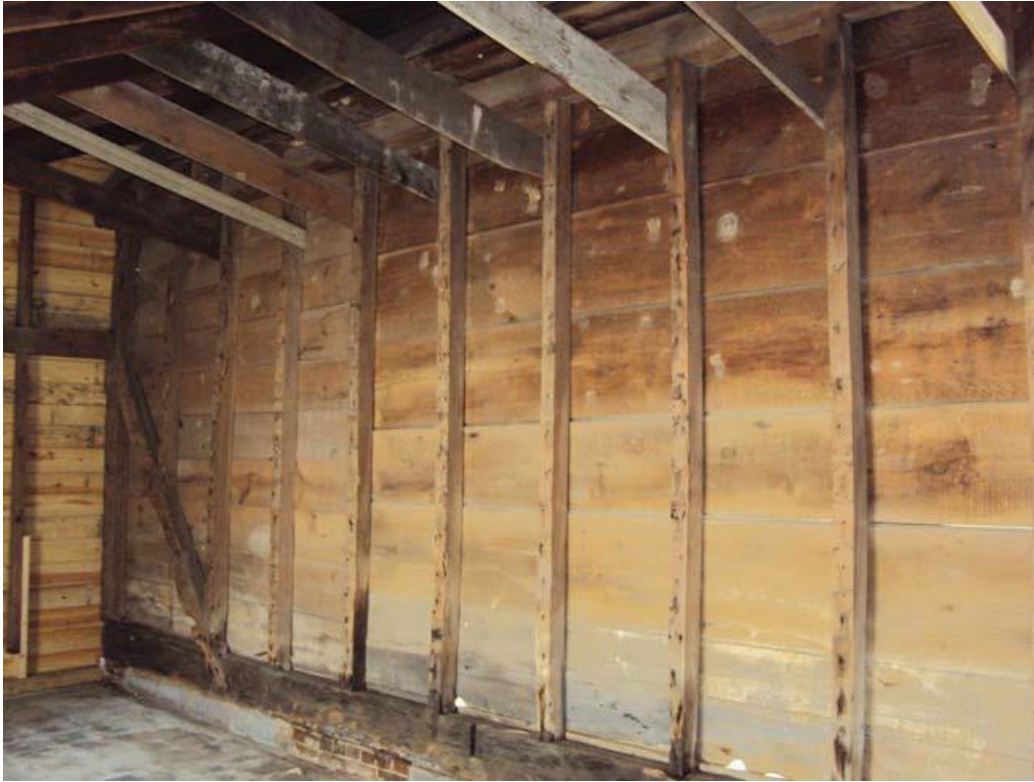
Exterior of original back (now west) wall of old store

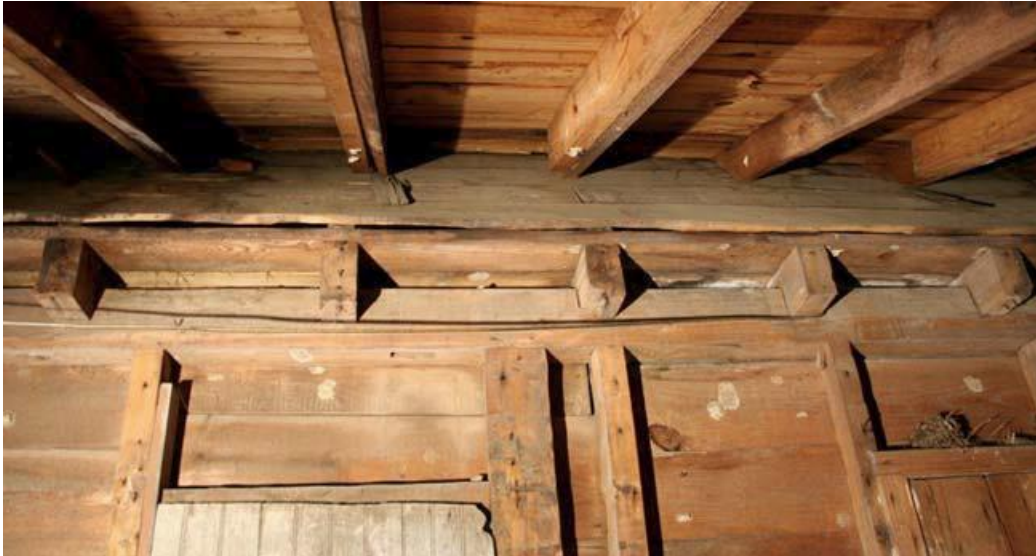
Exterior (present east) - details of original roof structure - photo by Jorin Hood

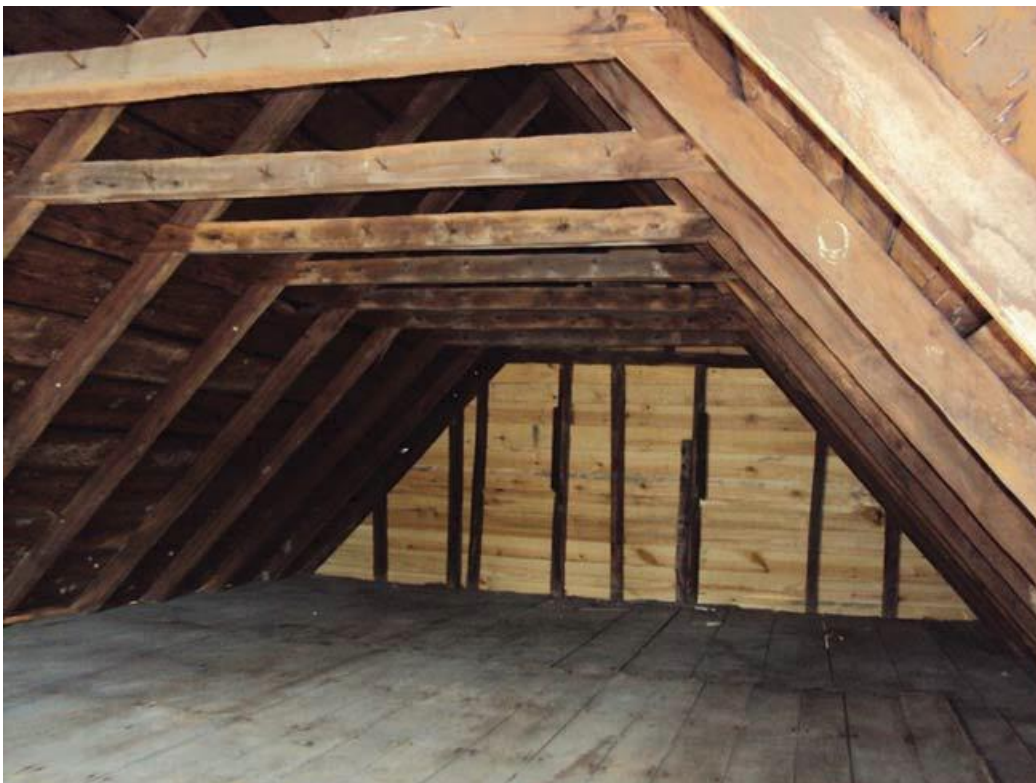
Attic - note neatly spaced nails on collar ties

The ceiling surface - and the ceiling joists - of both rooms evidences a thick, soft coating resulting from salt efflorescence. It is more visible at the south end of the building. It results from salted hams being hung to cure in the attic (nails are visible, neatly spaced, on each of the collar ties between the rafters of the roof). Salt was also probably stored there. The floor of the attic was thickly coated with residue, most of which was removed during the recent preservation efforts.

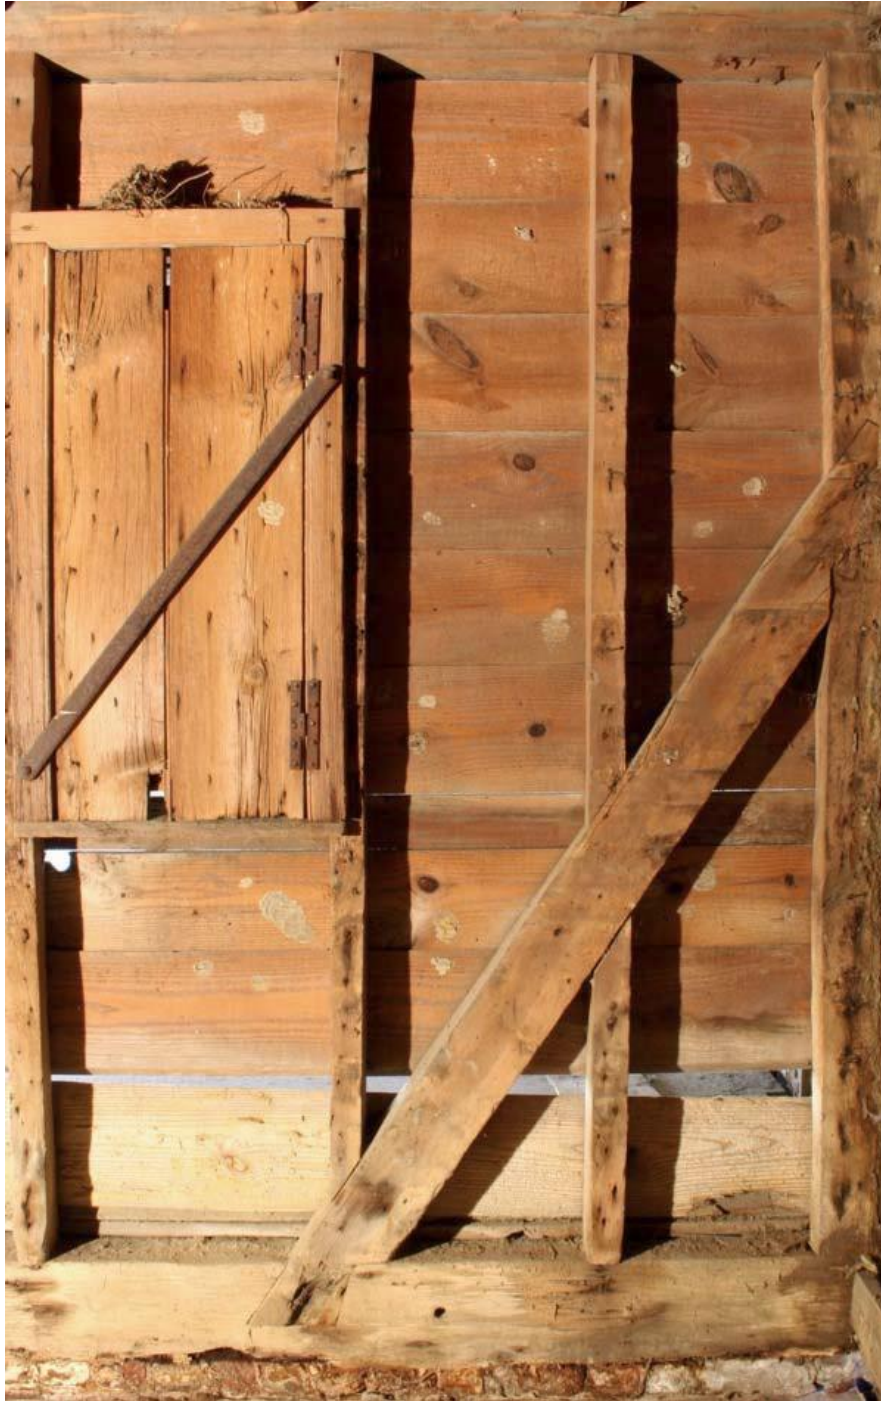
Exterior (present east) wall showing counting room window and corner brace - photo by Jorin Hood

The 4/4 wood sash counting room window is approximately centered on the east wall of the original room. There are *dados* for another window sill cut into the wall next to the existing window, against the original partition location. However, these *dados* appear to have never been used; the method of installing window frames necessitates the jambs being nailed directly to the flanking studs. Therefore, nail holes on the studs above the *dados* should be seen anywhere that a window was framed. There are no holes above the *dados* in this instance, suggesting that the window was originally intended for placement against the partition, but was moved further north before being framed. The exterior shutter on the window is original and, like the doors, is of double-layered sheathing with a beaded edge. It is hung on H-shaped side hinges.^[i] The shutter is secured by a wrought iron bar hung on a pin at the top of the jamb and run diagonally across the exterior of the window. A pin at the lower end of the bar would be wedged inside the shutter so that it could not be opened from the exterior. Every piece of the ironwork for this window is original.^[ii]

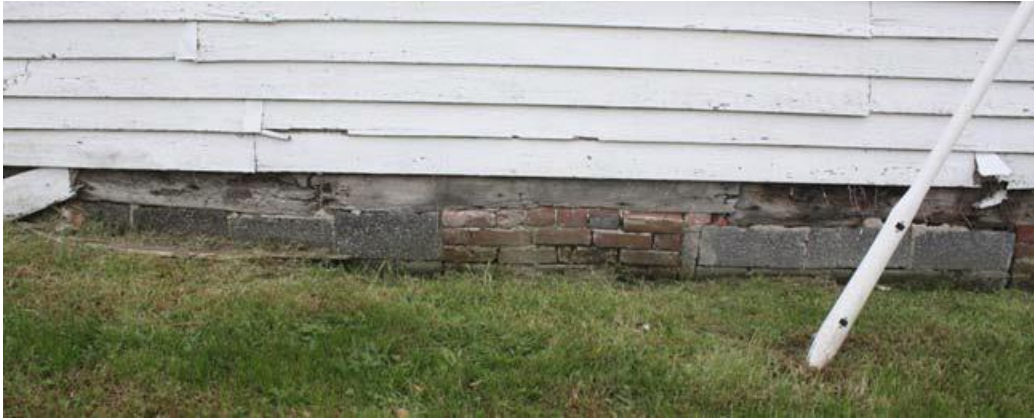
Photo by Jennifer Glass

The illustration above shows the original brick pier foundation and the north wall foundation prior to the changes of 2010, which are detailed in *Preservation 2010 Report*.

The foundation of the Thomas James Store is of brick piers laid in English bond with concrete block infill. This is probably not the original foundation, as the building was likely moved and set on a new foundation. However, since English bond was not commonly used past about 1825, the foundation is early if not original.[i] It is interesting that the foundation wall on the original front (now – after the building was moved from its first site – east) wall is full length, as it probably was when it was erected. It is as if, after the building was moved to its present site, the front wall was still fully finished to receive customers.

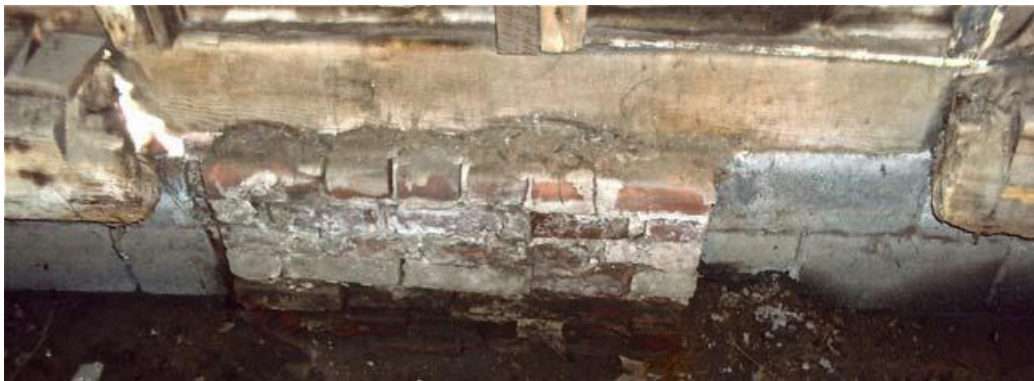
Sill (present north side, prior to 2010 preservation) interior showing cut for chimney

The Thomas James Store does not have a standing chimney. However, an examination by Mark Wenger produced evidence that the building did at one time have a chimney on the current north gable elevation, with a fireplace in the counting room of the store. A chimney thus located is almost universal in existing rural southern stores with a similar floor plan from this time period. The original sill on the north elevation of the building has a gap centered under the gable of the façade. A thin insert of timber closed the gap (until the sill was reinforced in 2010). This is where the chimney, with a width of 55", would have risen from the foundation. The two cut ends of the sill could be seen from the inside of the building beneath the floorboards, and each had been chased with a lap mortise into which the header of the hearth would have been inserted. The measurement between these laps, and thus the width of the original hearth, is 56¼". Although the original joist at the front of the hearth has been replaced, the joist's original drop mortises were still in place; measuring from these mortises to the inside of the north wall frame suggests that the hearth was 27" deep. The east side of the chimney was located 60" from the inside framing of the east wall. As there is no visible evidence of a fireplace at the attic level of the north gable, it is likely that the chimney had a set of shoulders at approximately attic floor level that narrowed the stack.^[i]

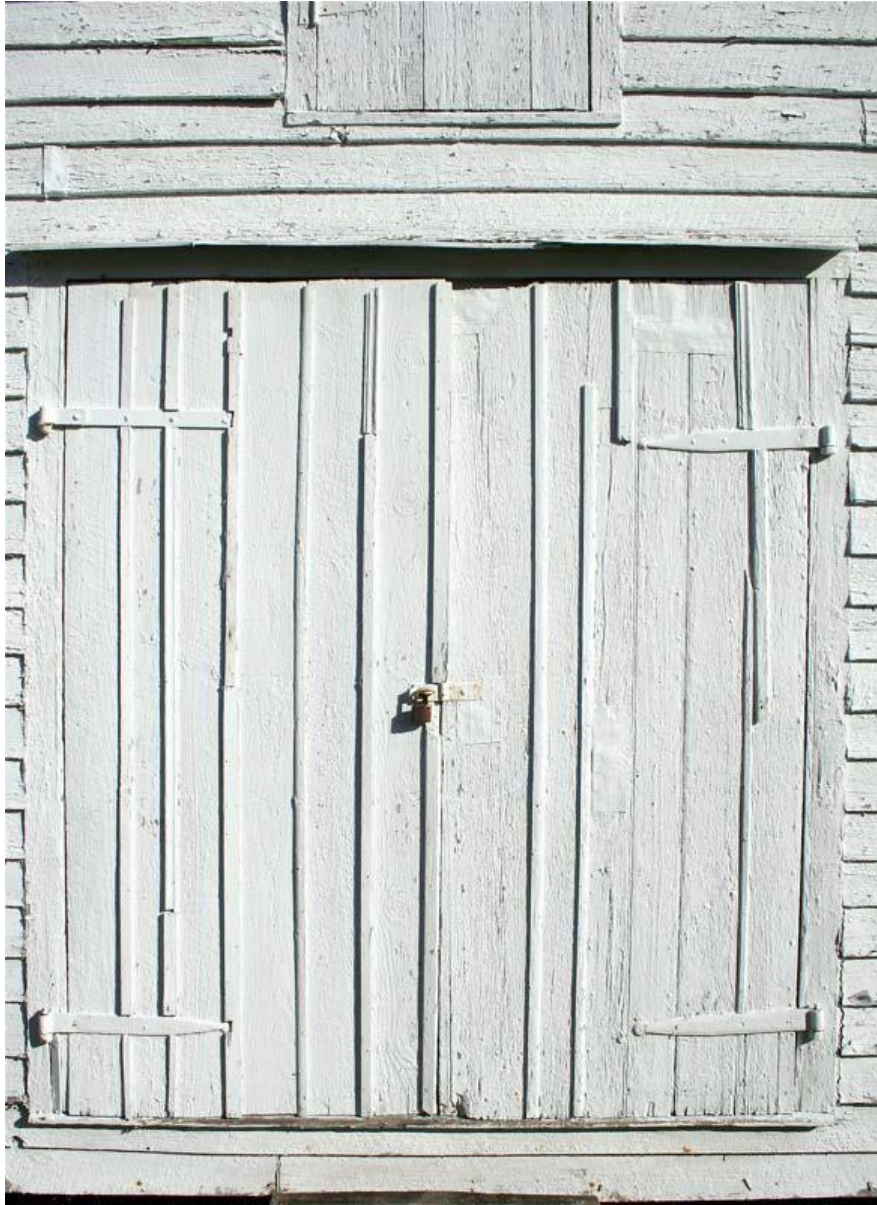
South (original north) wall double door - photo by Jorin Hood

Most of the store's original openings are no longer visible from the exterior, as they have been covered with weatherboard or are obstructed by the newer east and west wings. On the south elevation is a batten board double-leaf door which serves as an entrance to the building. Originally, this doorway would have faced the alley (now Maple Avenue) to the north of the building, and was probably used to load goods from the alley into the retail room. Although this opening is original, it was enlarged at some point and the original doorway was destroyed, though three of the original period hinges were kept. Mortises in the top plate of the doorway indicate that the original doorway was 41" wide, allowing 1 1/4" for the plank jamb linings. The

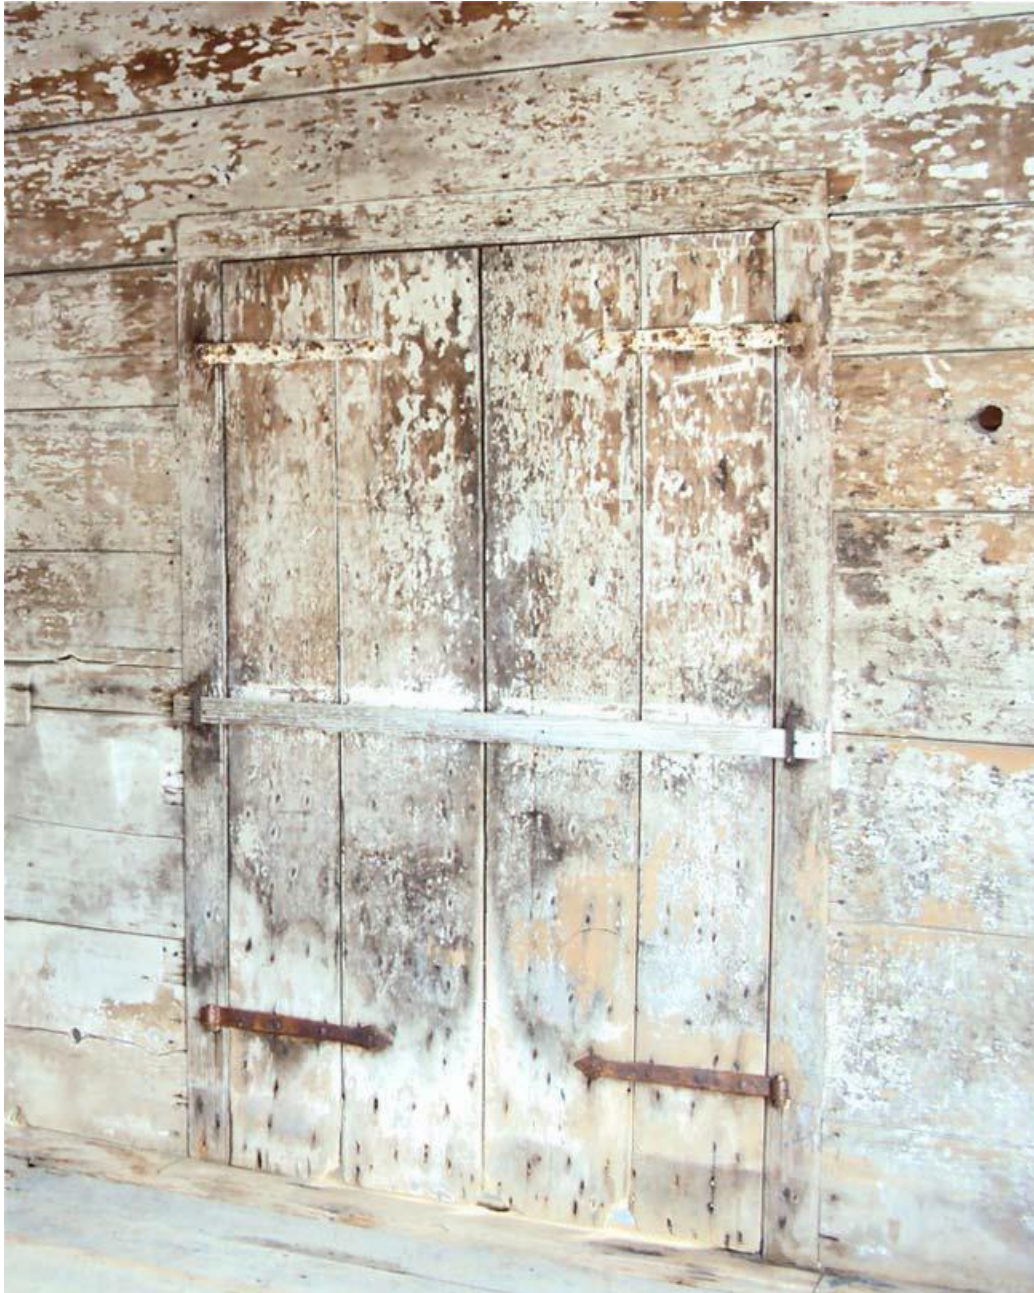
Interior of original front doors of old store

There are three openings on the east elevation of the original store, which are no longer visible on the building's exterior due to the east wing addition. The first is a double-leaf wood batten door, which would have served as the store's main entrance. This door is double-sheathed, with an interior horizontal layer and an exterior vertical layer of laminated sheathing secured together with clinched rosehead nails. The layers are offset 1/2" to form rabbets that fit the opposite door and the stops of the door frame. The exterior faces of the leaves have a beaded edge of approximately 2 1/4" width. The doors are hung on strap hinges with driven pintles and are secured on the interior by a wooden bar that is held at each jamb by a pair of closed keepers or staples. The lower hinges and pintles were badly rusted by 2010 and were replaced by identical, hand-made reproductions.

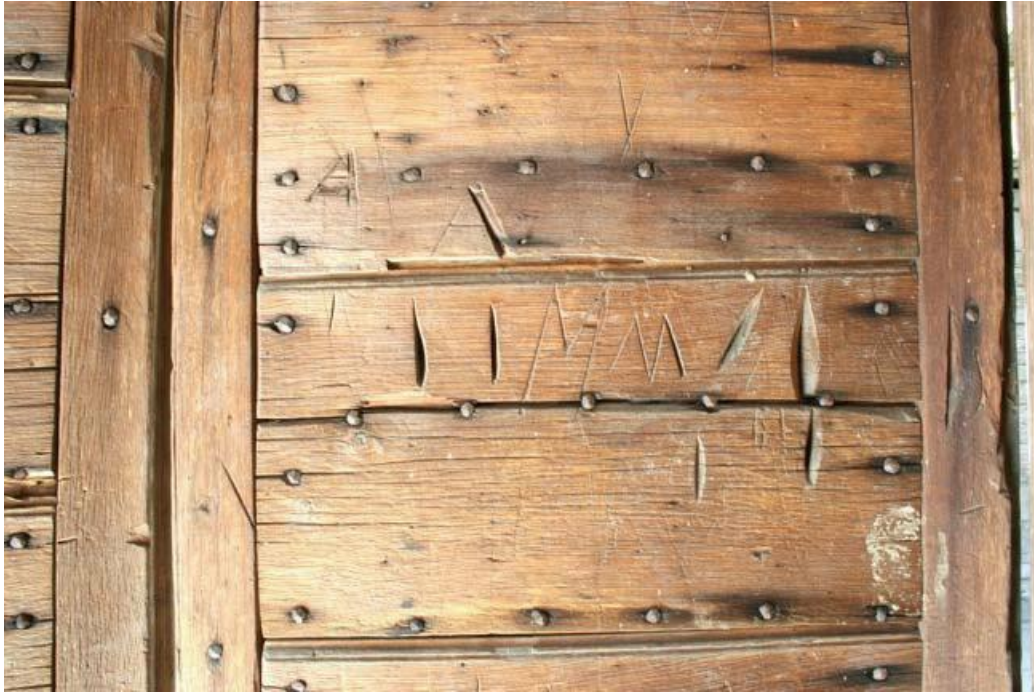
Detail of exterior of original front doors of old store - photo by Jorin Hood

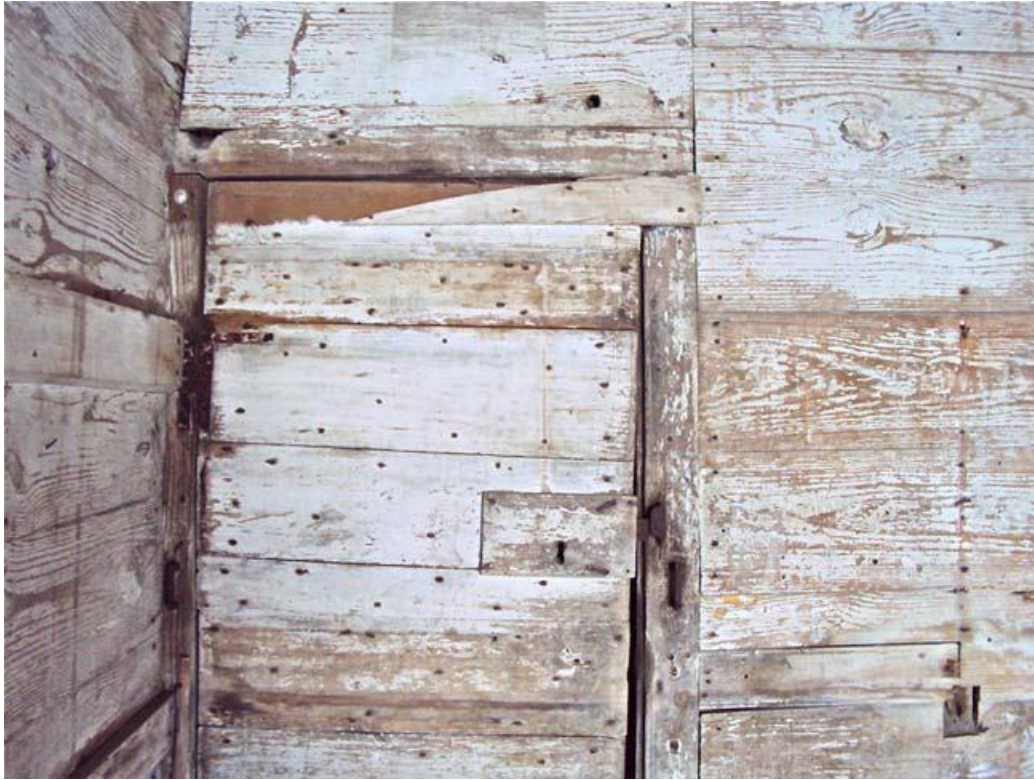
North wall (originally south) single door

On the north elevation of the store, covered on the exterior by weatherboard, is a single original double-sheathed door set against the northwest corner post, which served as an exit from the counting room. It is secured by a stock lock and staple, as well as a wooden bar set in keepers like that on the east entrance. This door swings on small H-L hinges, which are secured to the frame by clinched nails with leather botching behind the heads. All ironwork on this door is origi-

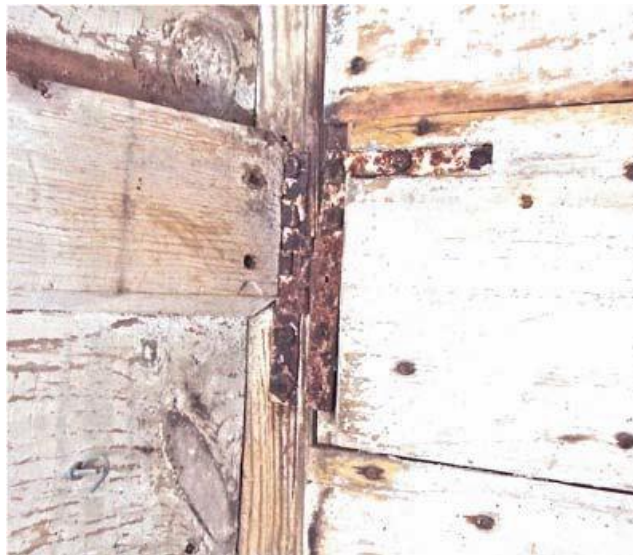
Detail of hinge showing leather washers.

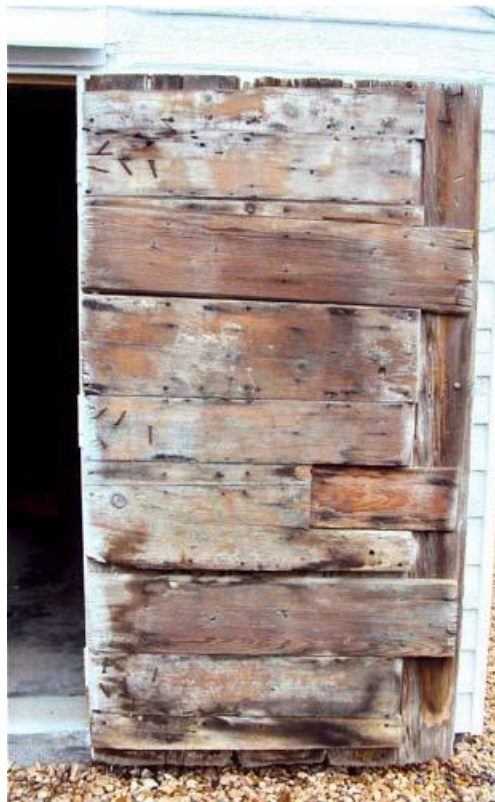
Interior surface of south wall single door

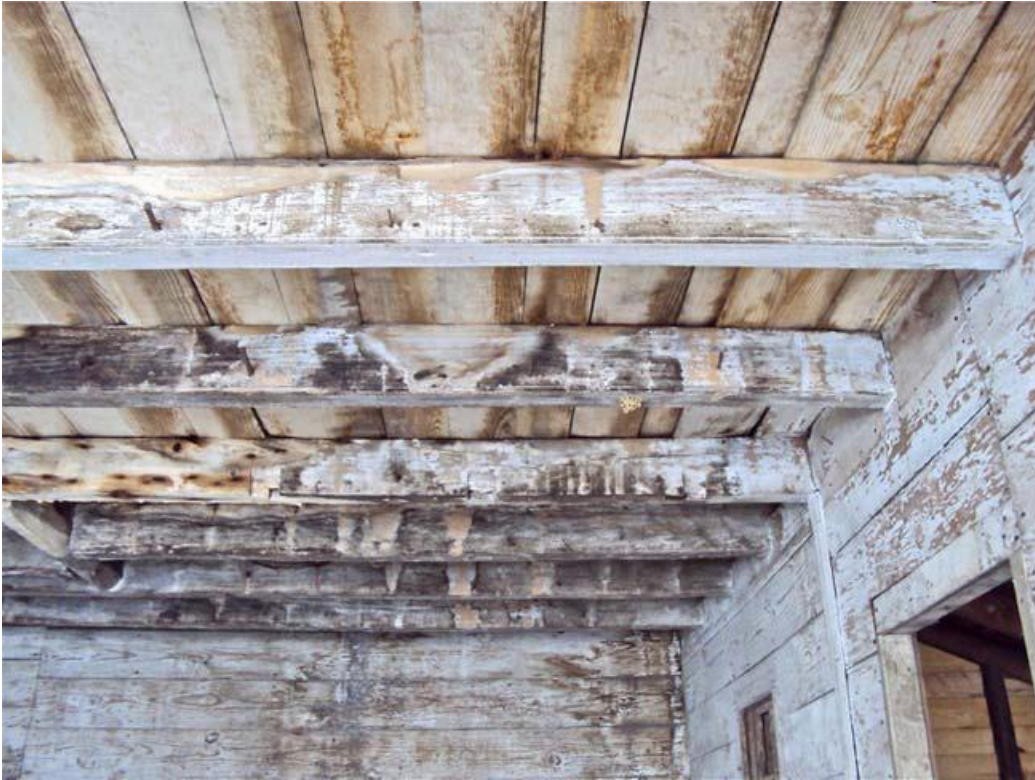
Beaded ceiling joists of retail room and unplanned joists in counting room, showing salt efflorescence

The wall and ceiling finishes in the retail room differ from those in the counting room, due to the likelihood that the counting room was intended to be finished with plaster. This is common among early stores; the counting room would have been the more nicely finished of the two rooms, while the retail room would have been simply sheathed to simplify wall shelving. In the retail room, the walls retain a lime-washed finish. They are sheathed with wide horizontal boards that are planed on their outer face and have a narrow beaded edge. The exposed ceiling joists are planed and beaded, and the underside of the flooring above was also planed smooth. This is an indication that the ceiling was meant to be exposed from the time of construction.

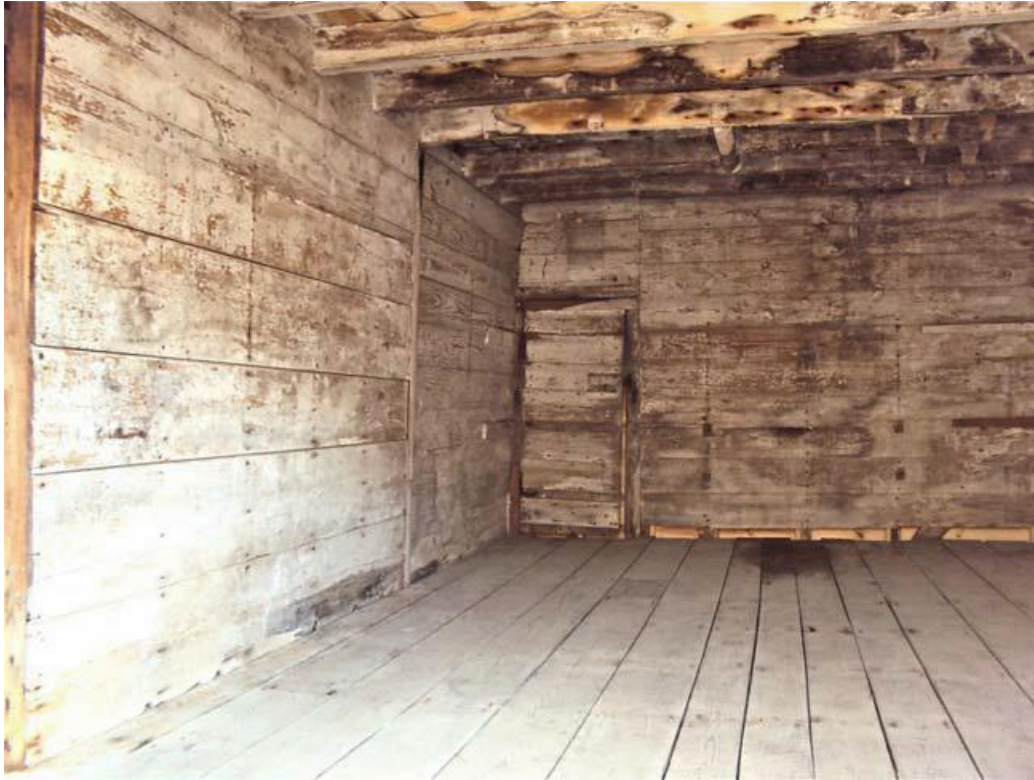
Original back wall of retail room, showing traces of shelves and brackets.

The interior of both rooms were covered in a lime-wash at some point, most likely when the interior partition was removed, as the finish was applied over the beveled board that covers the gap left by the wall. It is certainly not original in the counting room; when the present exterior siding was installed over the counting room door, a cleat was nailed over the top edge of the door to fasten it shut. Subsequently, this cleat split horizontally, revealing that there is no lime-wash underneath (see illustration of north wall door above). The finish was therefore not applied to the wall until after the new siding was installed. Both the retail room and the counting room were at one time shelved to display goods and for storage, and ghosts for the shelving can still be seen on the sheathing of the east, west, and north walls; the interior sheathing on the south wall has been removed. (See illustration above – "Original back wall of retail room...") The ghosts on the west wall, opposite the main entrance, are likely from the original shelving, as this is where the retail counter would have stood with display shelving behind. Two of the shelves, located approximately 33" and 60" above the floor, were supported with either ogee brackets or a straight stanchion two-nailed to the wall sheathing from both sides. The west wall shelving continues into the counting room, where it is likely a later extension of the original retail room shelving; there is a ghost of a shelf edge on the counting room door, indicating that the shelf was installed after the door was secured shut. This ghost shows a shelf of approximately 18" deep, which may have also been the depth of the retail room shelving. The shelving on the east wall of the store also seems to be a later addition, which is in keeping with the main entrance being on the (current) east wall, and therefore the unshelved public area of the retail room. The ghosts for the east wall shelving span the beveled board installed to cover the gap when the partition wall was removed, so at least this section of shelving, if not all of the east wall shelving, was installed af-

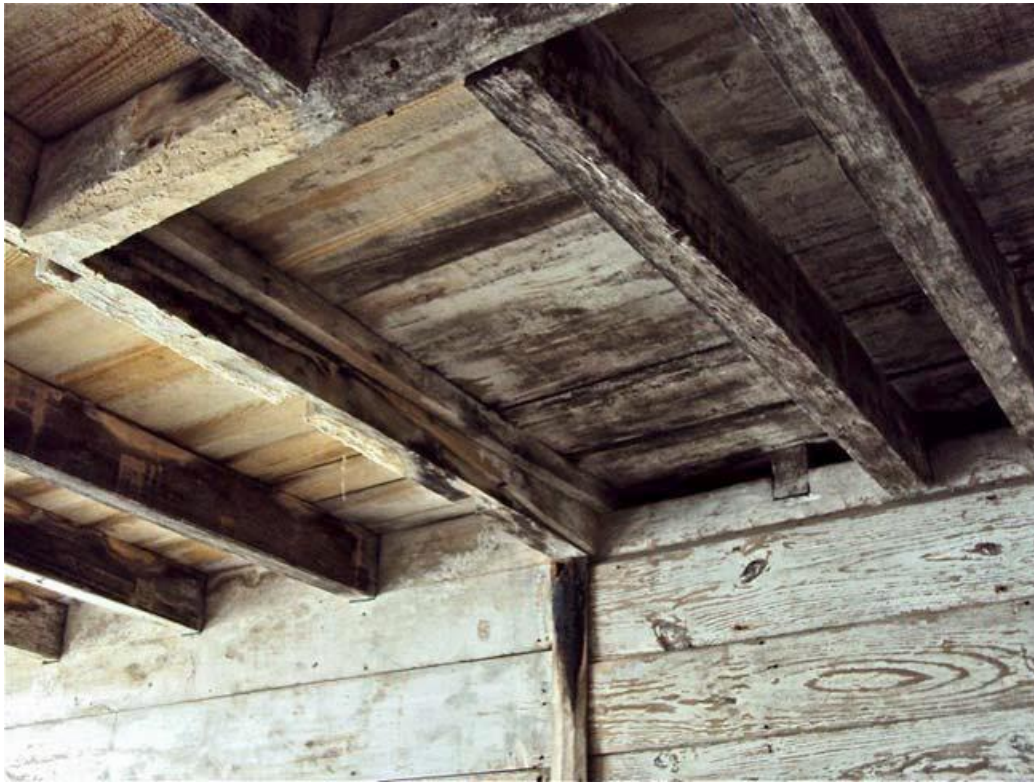
Ceiling joists of counting room showing original stair opening to the attic and original location of wall dividing the two rooms

The counting room walls are covered in horizontal bevel-edged board sheathing, dating to a remodeling that likely occurred in the third quarter of the nineteenth century.^[i] This sheathing predates the removal of the partition wall between the counting and retail rooms, as it stops at the vanished wall. The void in wall covering left when the partition was removed was covered with a beveled board. The counting room is trimmed out to be plastered, with an original base board, beaded chair board, and window trim. The hewn and pit-sawn ceiling joists were left unplanned, and the flooring above was gauged and undercut rather than smooth finished, indicating that the ceiling was to be covered in plaster as well. However, though the room was obviously intended to be plastered, it does not appear that plaster was ever actually applied. An inspection behind the sheathing on the north wall produced no sign of plaster. The bevel-edged sheathing appears to be the only finish ever applied to the counting room walls. Since the sheathing on the north wall may be later than that on the east and west walls because it covers the opening where the chimney once stood, Mark Wenger recommends examining beneath the sheathing on the adjoining east wall to be certain that none of the counting room walls were ever plastered.^[ii]

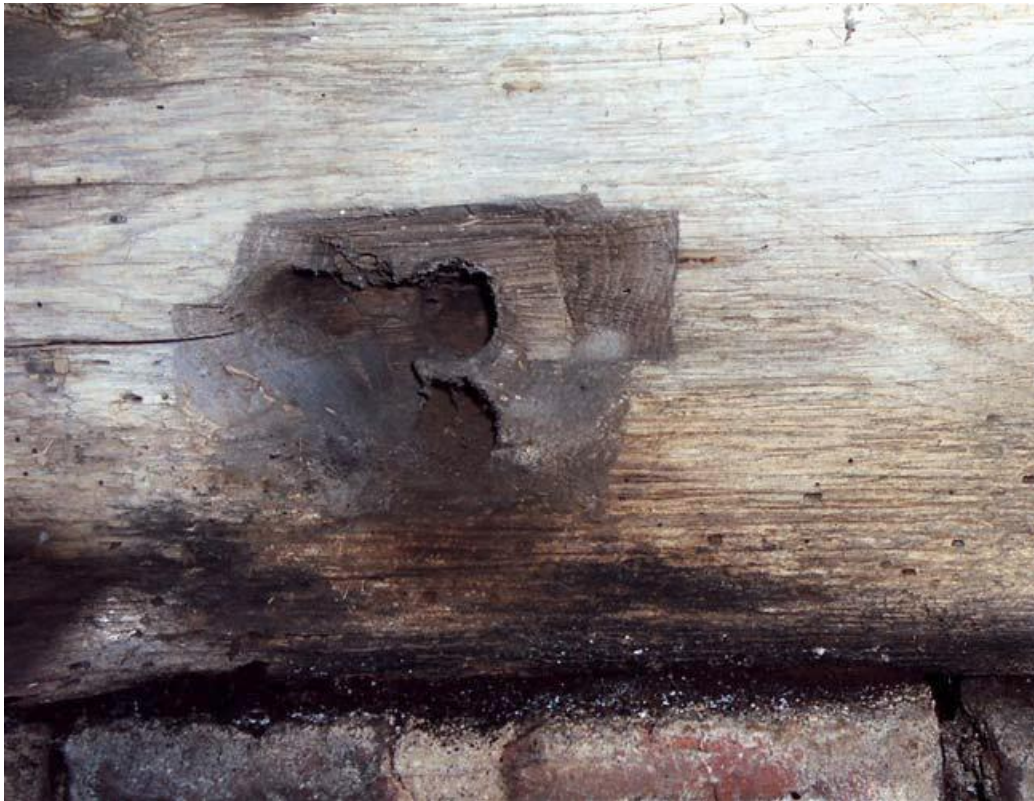
Below is seen an unusual feature (on the outside of the current south end of the east sill, and matching an identical feature on the west sill), which was likely where the cables used to move the building were bolted. From its original location, therefore, the building would have been winched (with block and tackle) or towed (by horses, mules, or oxen), rolling on logs, and moved northward into the alley, then turned in an eastward direction and rolled until it was turned again southward and its present destination reached. This accounts for the 180-degree change in its axis.
